## TDP 9 - Design, Installation and Performance Assessment of an Air Sparge Curtain System

Originally published September, 2004

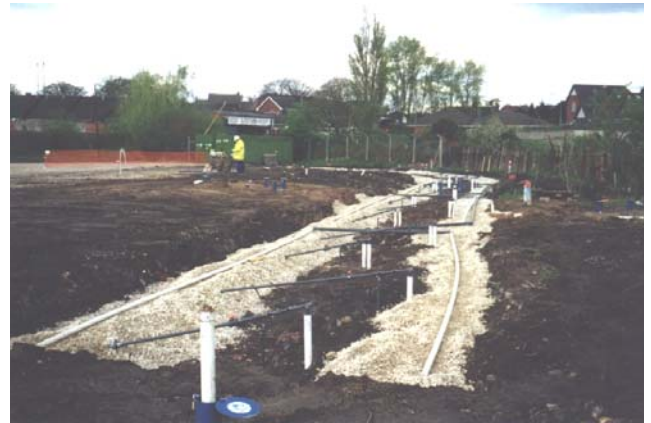
SVE extraction pipework laid horizontally

The air sparging curtain, consisting of 22 vertical air injection points, creating a linear treatment zone inside the eastern and northeastern site boundaries,

was combined with a soil vapour extraction (SVE) system to capture and treat off-gas. The integrated system was installed at the site in August 1999 and operated for over 3 years and was finally decommissioned in January 2003. The installation works were carried out under a Mobile Plant Licence granted by the Environment Agency (EA).
